# INTERREG AURORA NEW NORTH PROJECT WP1 – REPORT 2

## BOTTLENECKS AND IMPROVEMENT OPTIONS

*"New North -Transport, Logistics, and Security of Supply"  
is an Interreg Aurora project-collaboration among the  
regions of Northern Norway, Northern Sweden and  
Northern Finland. The project is co-funded by the EU's  
Interreg Aurora programme.*

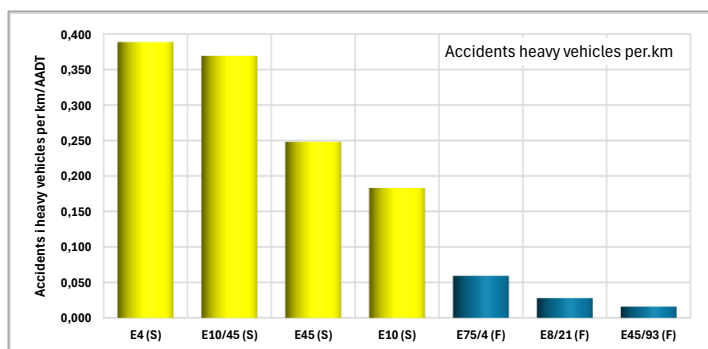
Most heavy-vehicle accidents occur on **road sections with the highest traffic volumes, particularly the E4 and E10 in Sweden.**

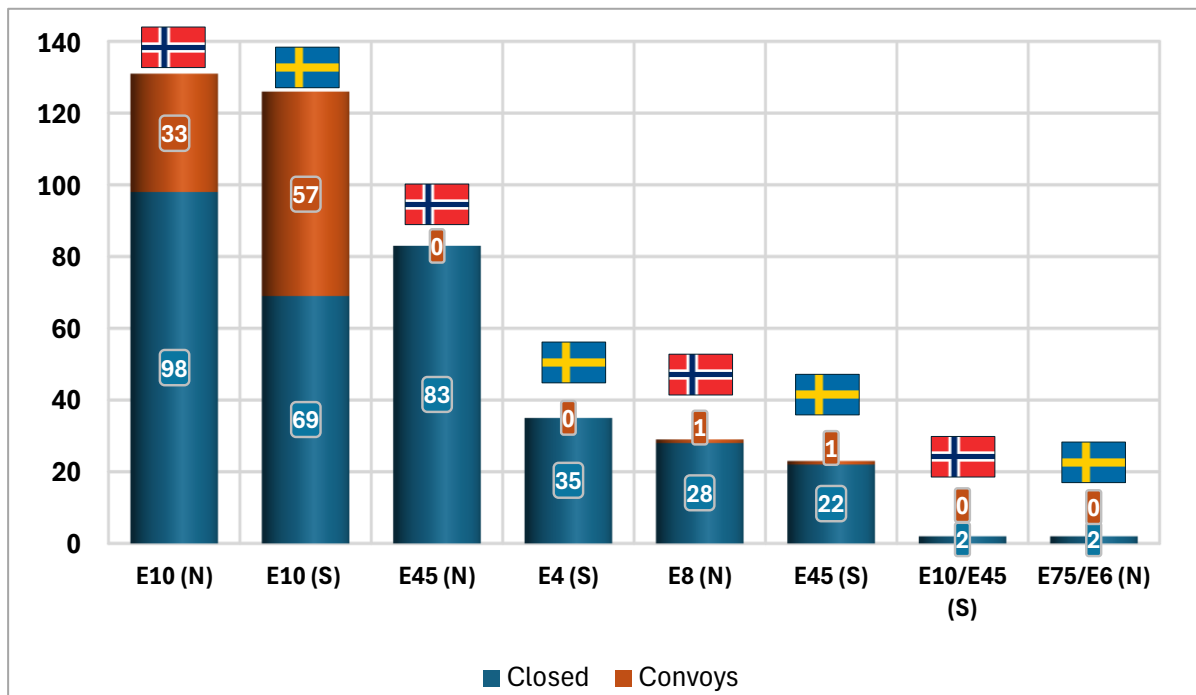
The numbers of closures and convoy operations by road section, and for the period October 2021-March 2025, is illustrated in the figure below.

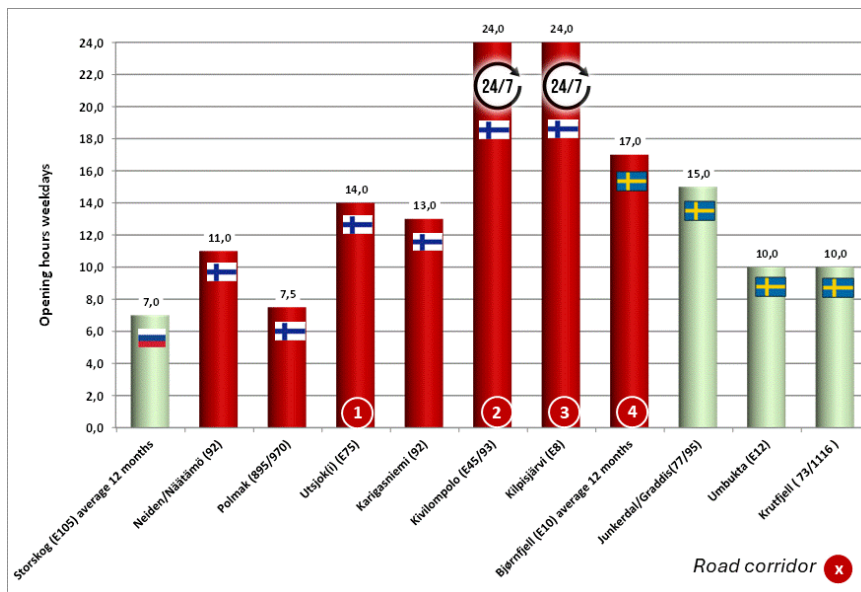
In Northern Norway, **11 border-crossing (customs) stations** support heavy industrial transport. The stations highlighted in red in the accompanying figure were included in the questionnaire survey, and the numbers 1–4 correspond to the WP1 corridors.

**Only two of the eleven stations operate 24/7.** The figure provides an overview of all stations and their respective opening hours.

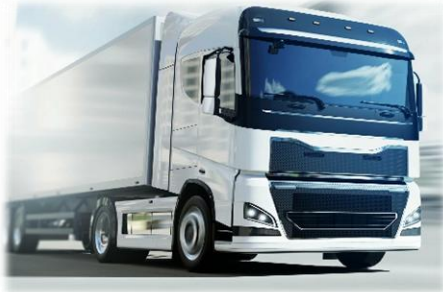
The selected road transport corridors (1-4) are:

- 1 Eastern-Finmark ↔ Utsjok**
  - a. Tornio ↔ North-Finland
  - b. Tornio ↔ Haparanda ↔ North-Sweden
- 2 Western-Finmark ↔ Kivilompolo**
  - a. Palojoensuu ↔ Karesuando ↔ North Sweden
  - b. Palojoensuu ↔ Tornio
    - i. Haparanda ↔ North-Sweden
    - ii. North-Finland
- 3 Troms ↔ Kilpisjärvi ↔ Karesuvanto**
  - a. Karesuando ↔ North-Sweden
  - b. Palojoensuu ↔ North-Finland
- 4 Nordland/Troms ↔ Bjørnfjell ↔ Töre**
  - a. North-Sweden
  - b. Haparanda/Tornio ↔ North-Finland

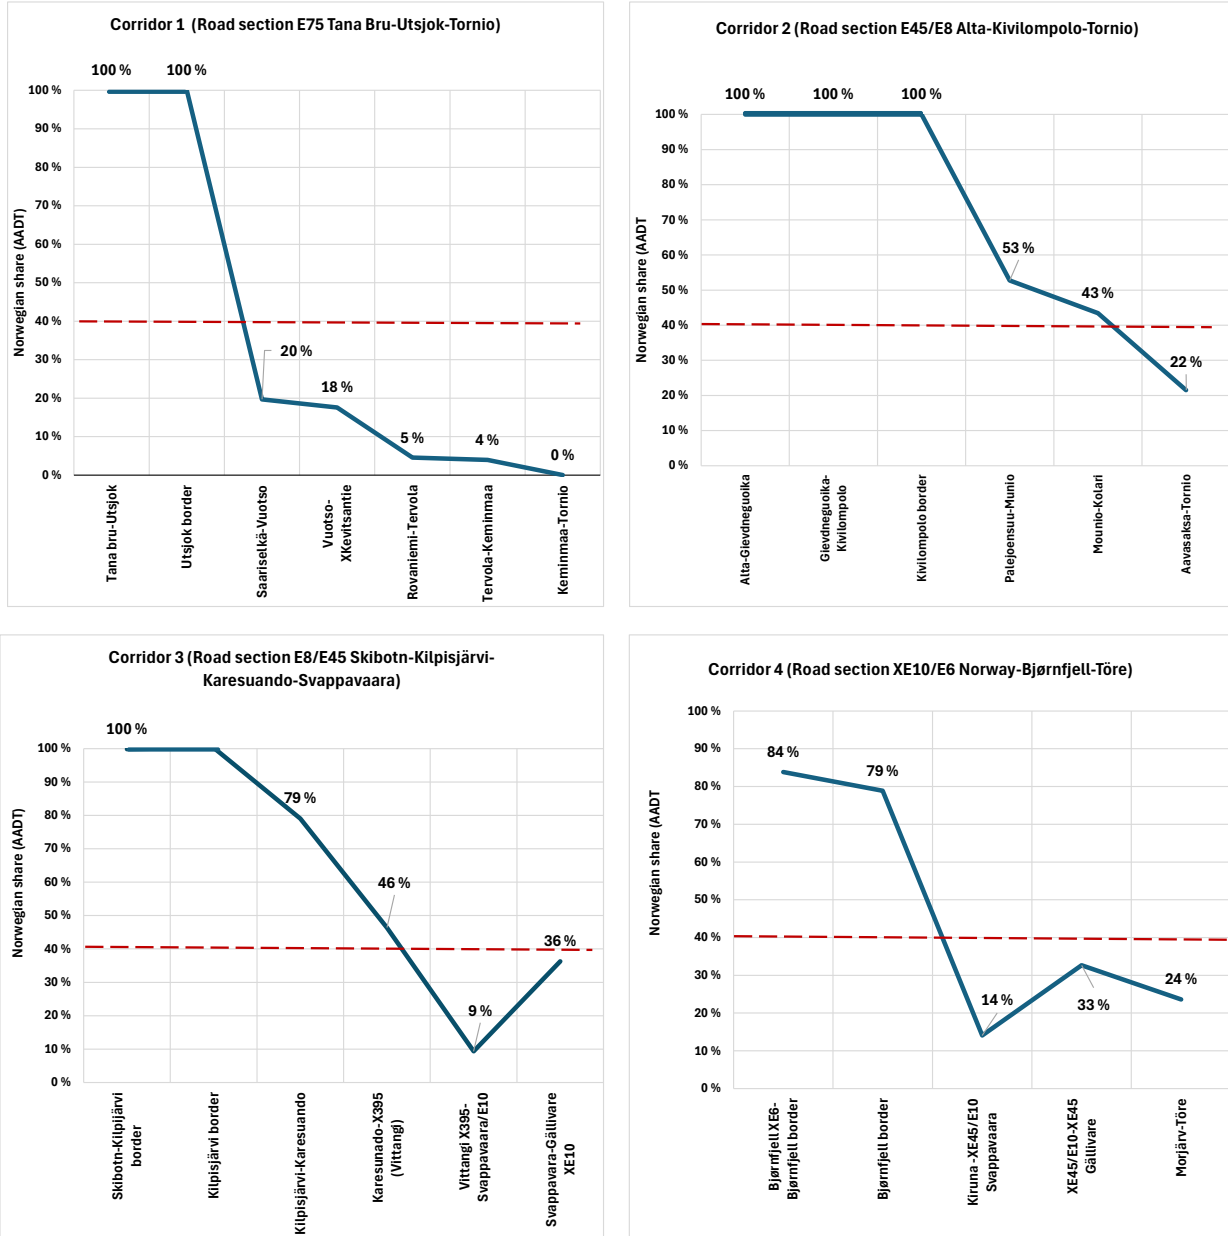
Figure 3-1: Norwegian share of the transports in sections of the various corridors

The proportion of Norwegian transport within the selected corridors is highest in the northern parts of the region. This share gradually decreases as road transport volumes increase toward the southern areas. The figure below shows the share of Norwegian transports along four sections of the selected corridors.

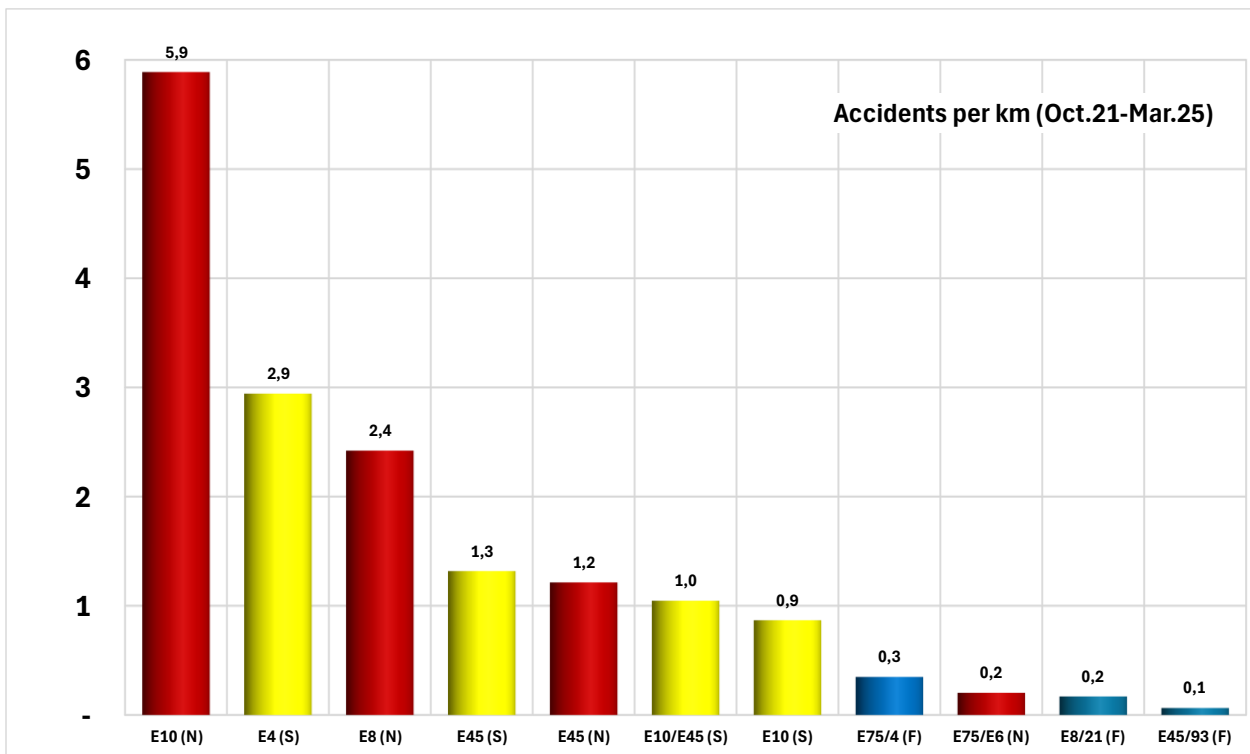
Figure 7-2: Accidents total (Oct.21-Mar.25) per km and road section

- When distance is considered, it is possible to indicate the accident rate relative to the length of each road section (see table 7-1 on page 27).
  - Figure 7-2 illustrates the number of accidents per km for the respective road sections. The figures represent the **total number of accidents registered during the period from October 2021 to March 2025**.
  - Based on this approach, the accident rate per kilometre in **Finland is relatively low**, ranging from 0.1 to 0.3 accidents per kilometre during the measurement period. In contrast, the **E10 in Norway shows the highest accident rate**, at 5.9 accidents per kilometre. It should be noted that the Norwegian section of the E10 is the **shortest** among all road segments included in this report, with a total length of only 36 kilometres.

- To enable a more consistent comparison, accident rates have been calculated per kilometre of road (see figure below). When adjusted for distance and based on reported data, **Finland shows a relatively low accident rate**, estimated at 0.1–0.3 accidents per km for the observed period.

- The **E4 in Sweden has the second-highest accident rate** per kilometre. However, this corridor carries significantly higher traffic volumes (AADT) than most other road sections in the WP1 region, particularly those located further north. The elevated traffic load is therefore likely a key factor contributing to the higher accident rate observed on the E4.

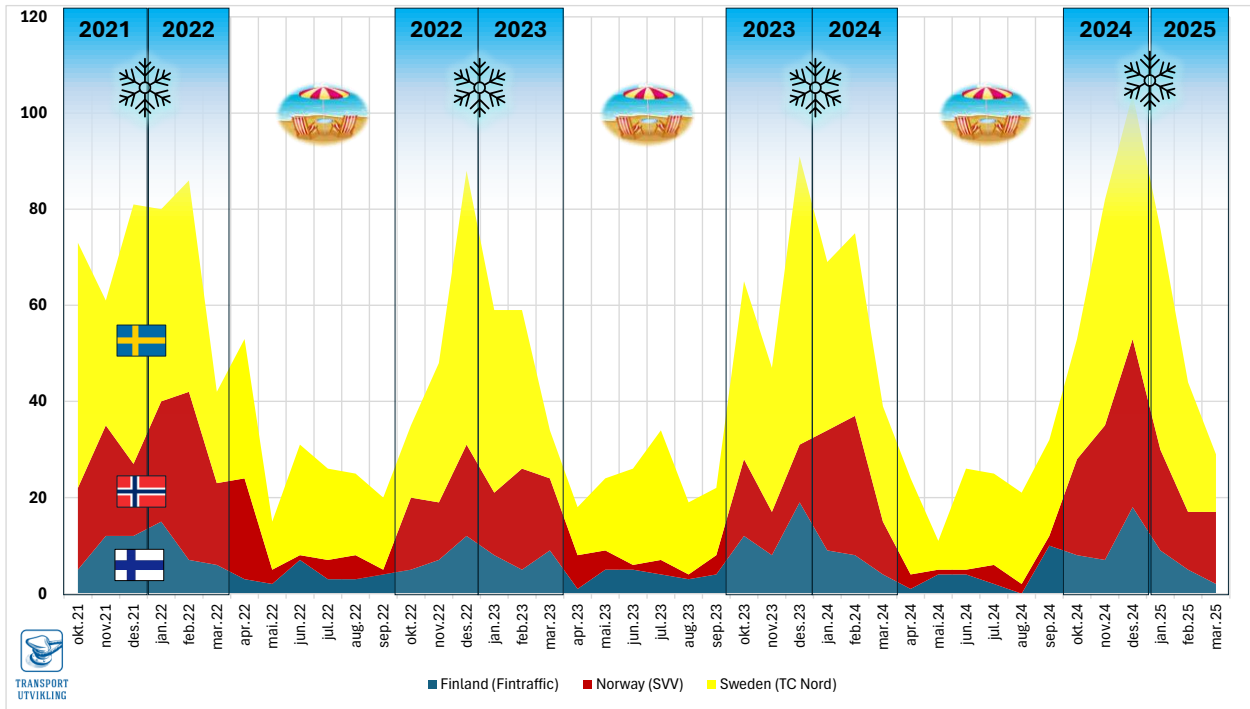
Figure 7-3: Seasonal distribution of accidents (all roads)

Statistical analysis enables us to verify and quantify this perception. The accumulated seasonal distribution of accidents is presented in the figure below.

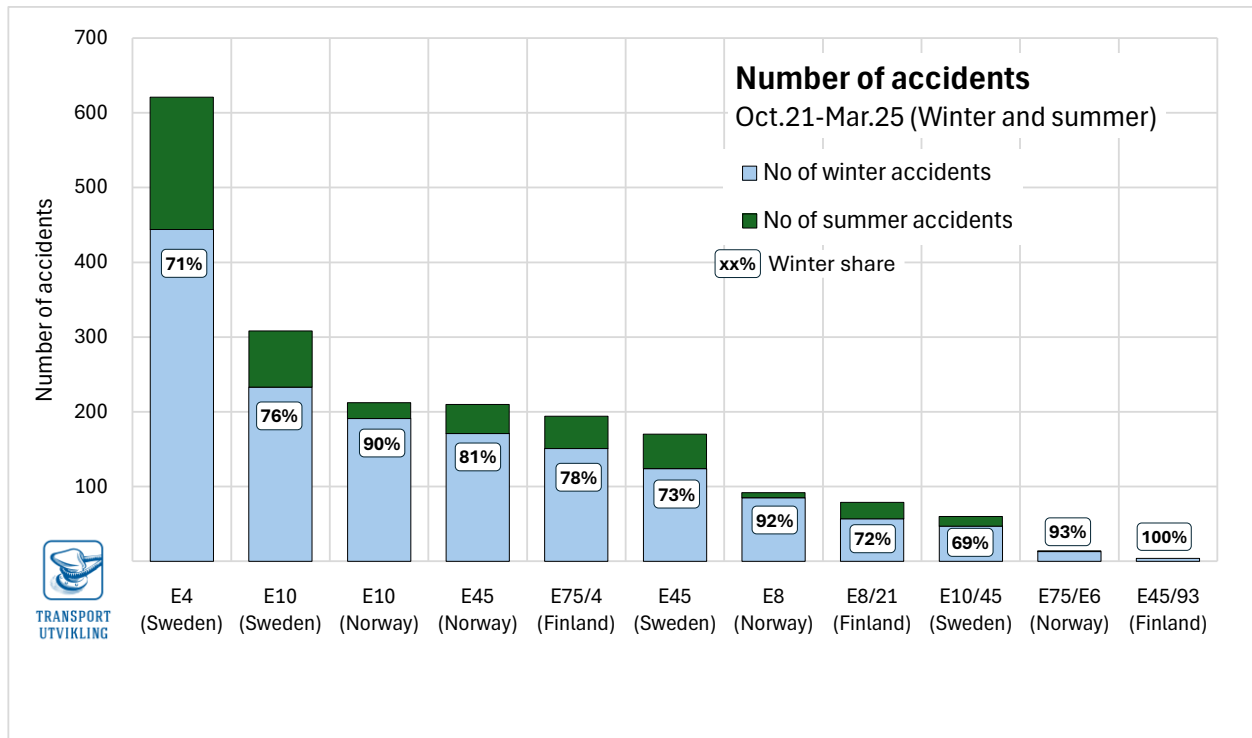
Figure 7-4: Winter and summer accidents per road section

Figure 7-4 presents all registered accidents for each **country and road section** where data were available.

The largest share of winter accidents is observed along the Norwegian section E10, E8 and E75/E6.

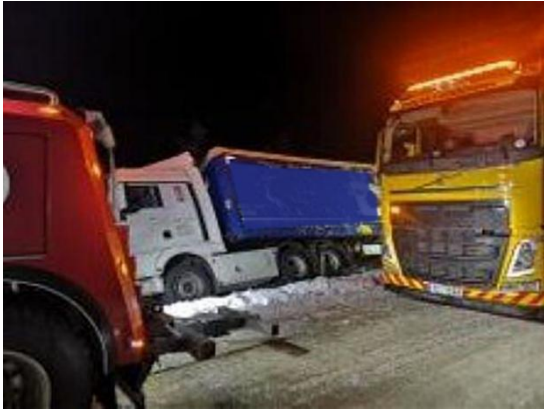
The picture shows a tow truck rescuing a heavy vehicle that went off the road, approximately 4 km south of Pättikkä (Enontekiö, Lapland) along E8/21.

The photo was taken by the tow truck company Skibotn Bilbergning on December 9, 2024.

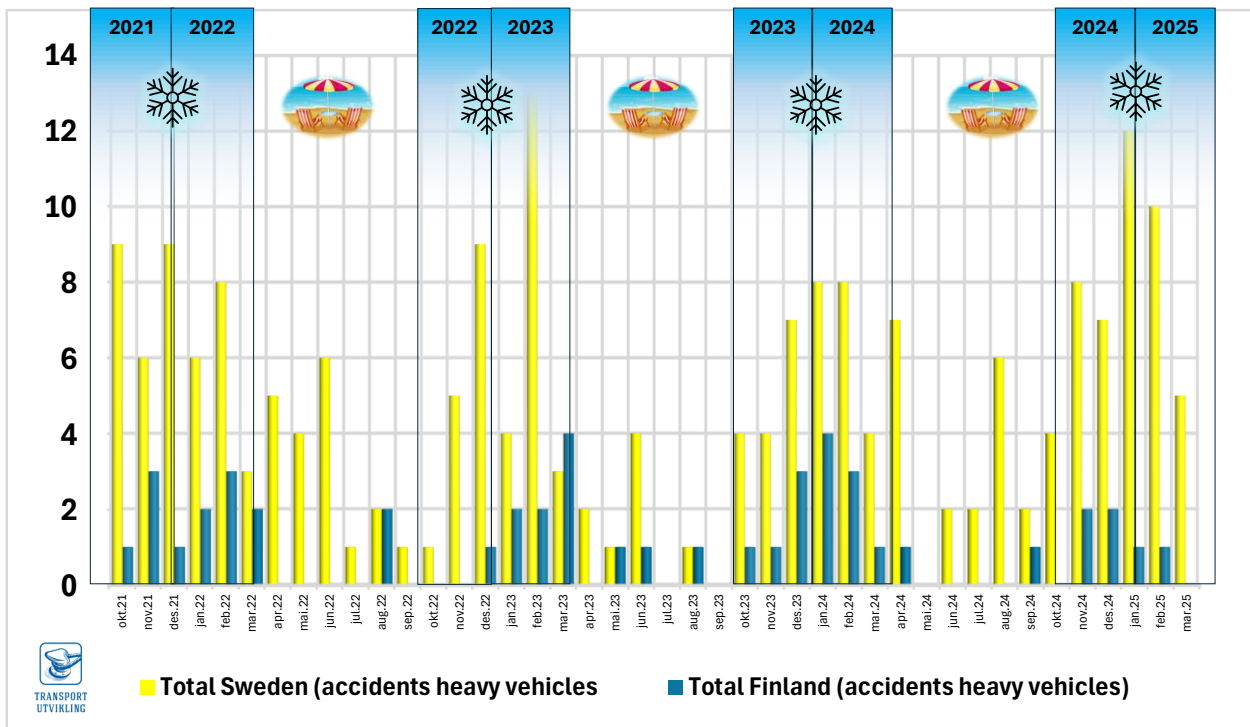
Figure 7-5: Distribution per month/year of accidents involving heavy vehicles (Finland and Sweden).

The monthly and yearly distribution of accidents involving heavy vehicles in Finland and Sweden is presented in figure 7-5.

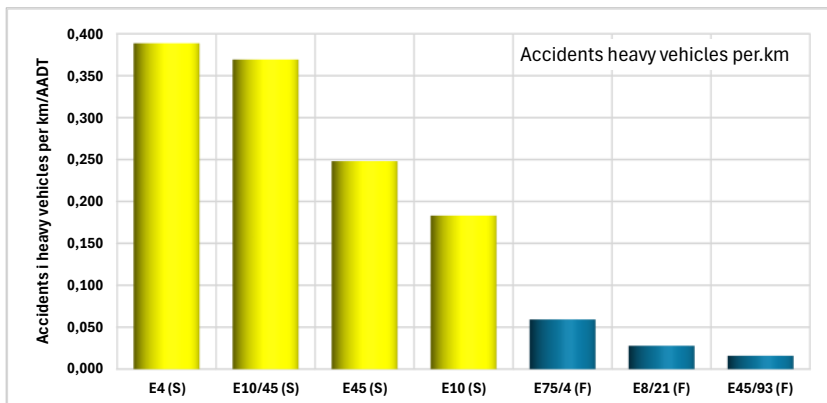
Figure 7-7: Accidents involving heavy vehicles, per road and road-km in Finland and Sweden (Oct.21-Mar.25)

When the number of accidents per road section is **related to the length of the section (km)**, the highest accident rates are observed on the Swedish road sections, particularly along the E4 and E10/E45.

When taking **road length into account**, the highest accident rates involving heavy vehicles are **also found on Swedish corridors**, most notably along the E4 and the E10/45 routes.

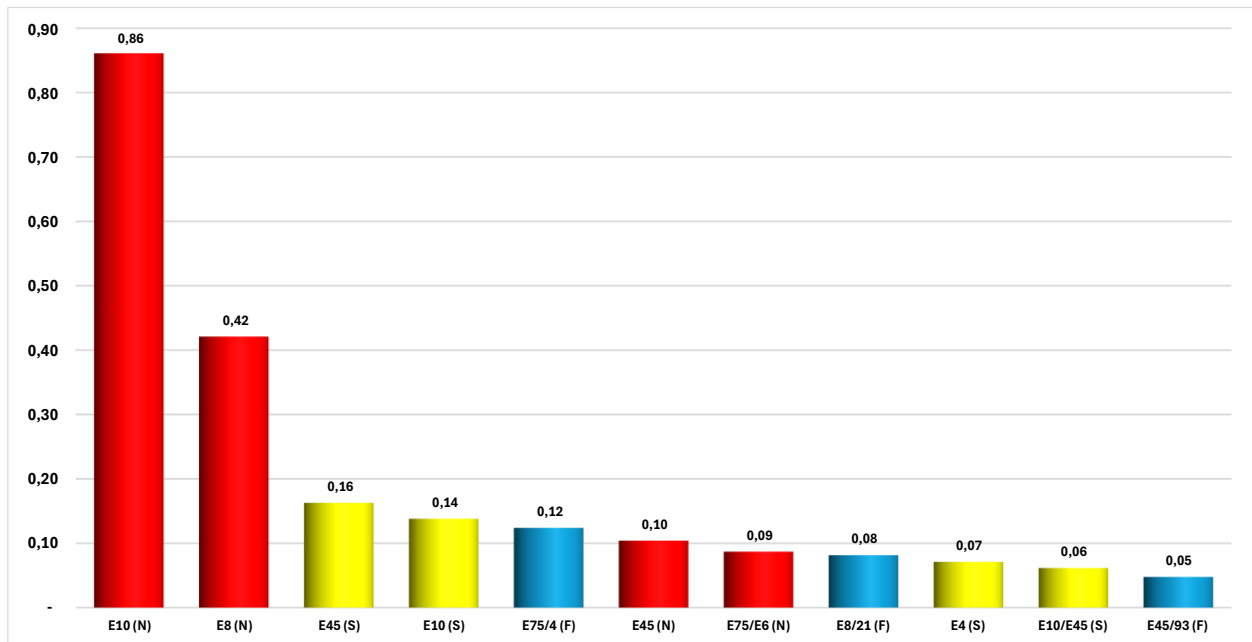
Figure 7-9: Wild animal accidents per road and road-km (Oct.21-Mar.25)

Figure 7-9 presents the different road sections and the number of wild animal accidents per road kilometer for the period **October 2021 – March 2025**. Based on this approach, **the highest accident rate per km is observed along the short road sections of E10 and E8 in Norway.**

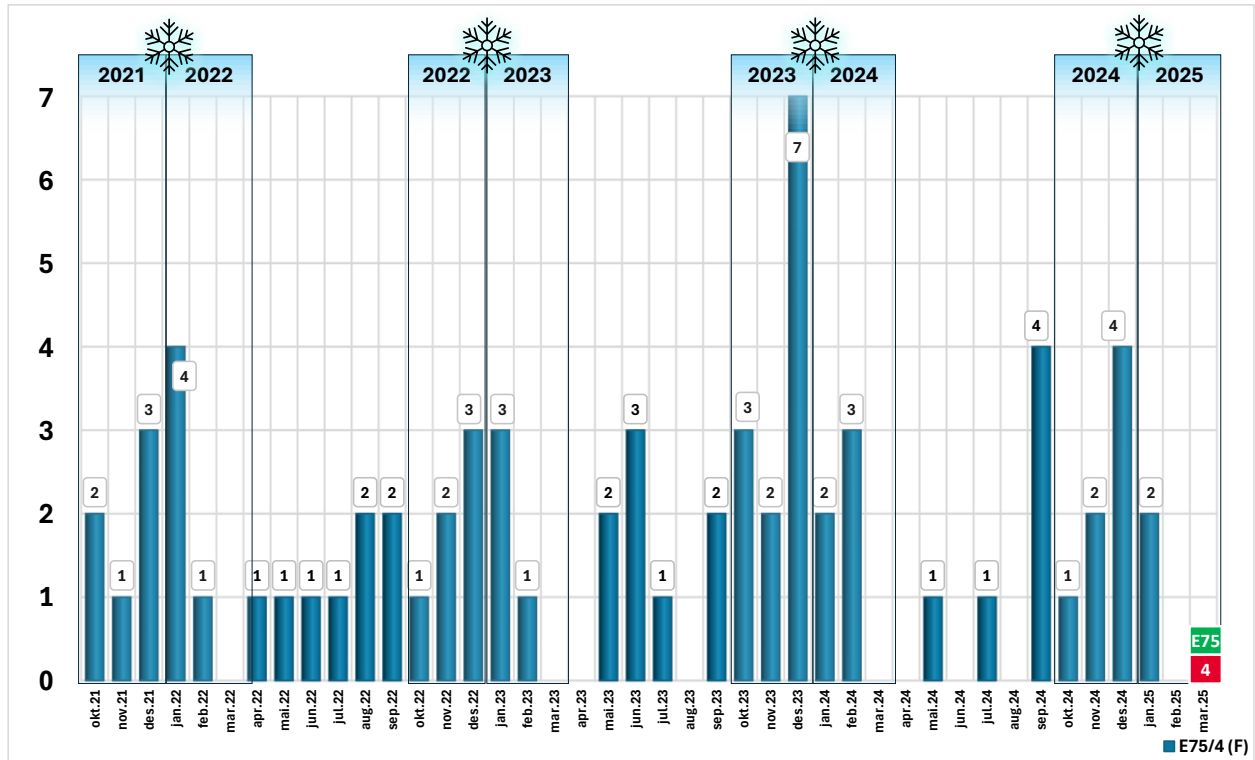
Figure 7-10: Accidents involving wild animals (E75/4 in Finland)

Approximately 26% of all recorded accidents occurred along E75/E4 in Finland. The monthly distribution of accidents on this road section during the period October 2021 to March 2025 is presented in the figure below.

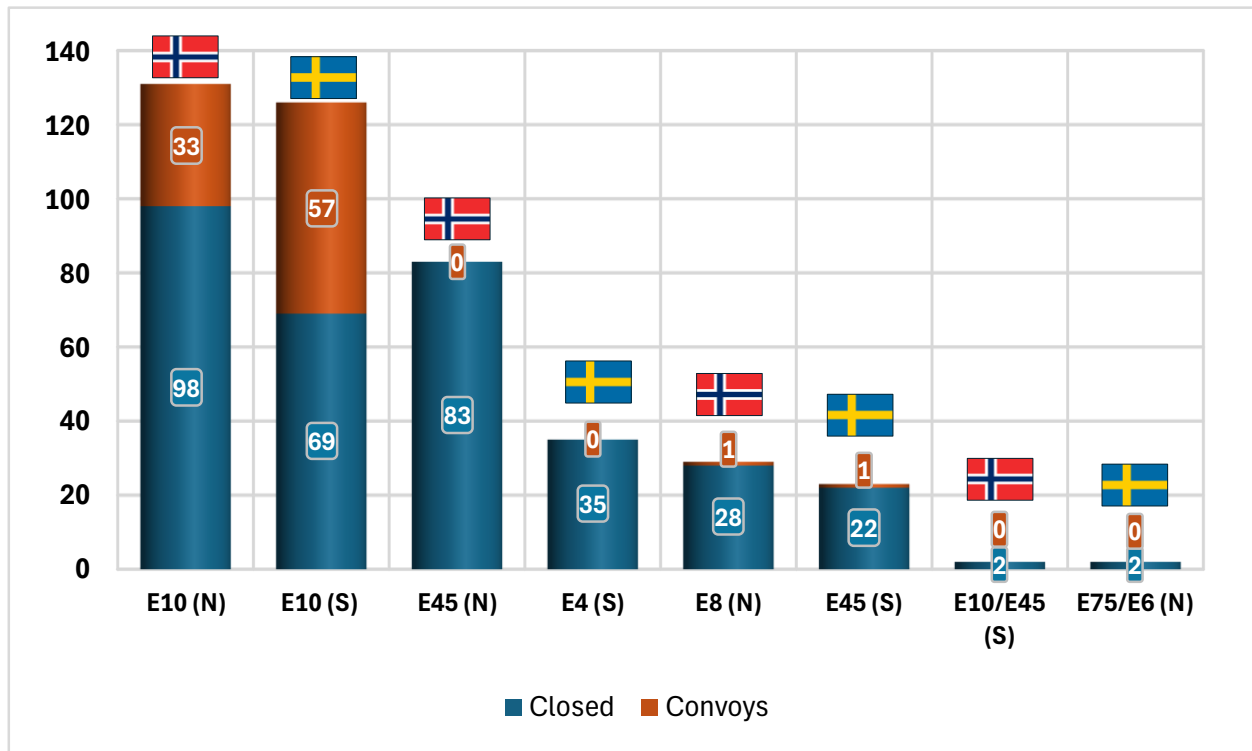
Figure 7-11: Number of closures and convoys (Oct. 2021-Mar. 2025), road sections in Norway and Sweden

The figure below is based on SVV’s classification of “closed roads,” even though some reported closures may in fact represent convoy operations. In either case, both classifications result in limited mobility. The distribution of closures and convoys, per road, is shown in figure 7-11.

- Most road closures and convoy operations (October 2021–March 2025) occurred along the E10 in Norway and Sweden.
  - The E10 accounts for close to 50% of all recorded closures across the road sections shown in the figure above.
  - It also represents 98% of all recorded convoy operations, underscoring its vulnerability to severe winter conditions.
- Most closures and convoy operations on the E10 were concentrated near the Norway–Sweden border, particularly in the Bjørnfjell area, which stands out as a critical bottleneck during winter.

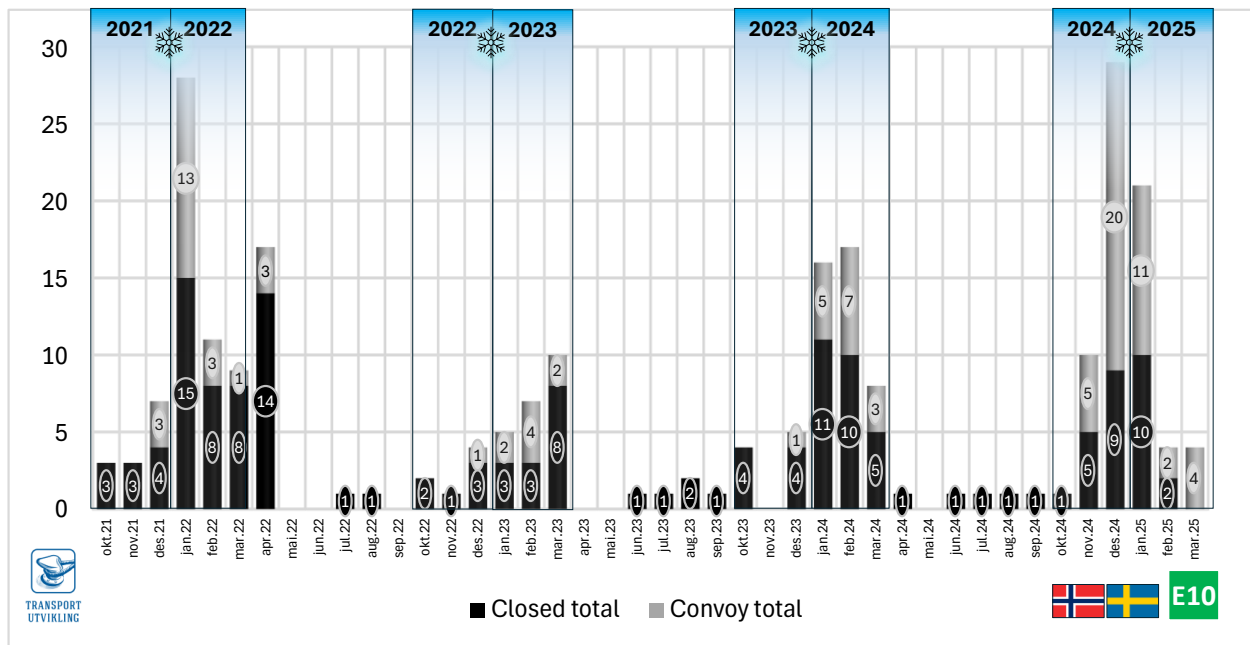
Figure 7-13: Number of closures and convoys, E10 Norway/Sweden

The figure demonstrates that closures, and particularly convoys, are predominantly winter incidents. While closures may also occur during the summer months, these are typically linked to accidents, landslides, or other isolated events rather than seasonal conditions.

The peak period of disruption is observed in December and January, which consistently record the highest number of incidents. In December 2024 alone, a total of 29 closures and convoys were registered, underscoring the severity of winter impacts on traffic along the E10 corridor.

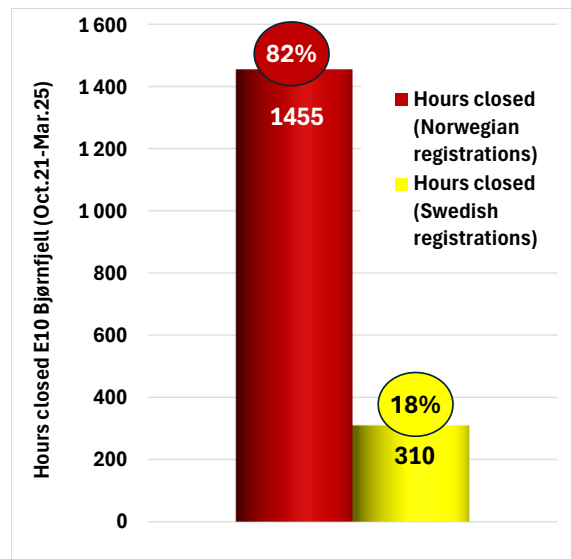
Figure 7-15: Hours closed, E10 Bjørnfjell (Oct.2021-Mar.2025)

- If we consider only the closure hours reported by Norwegian authorities:
  - ✓ Total closure time decreases from 1,765 hours to 1,455 hours (a reduction of approximately 18%).
  - ✓ Average monthly closure time (12 months/whole year) changes from 42 hours to 35 hours.
  - ✓ Average monthly closure time (6 months/winter) changes from 84 hours to 69 hours.

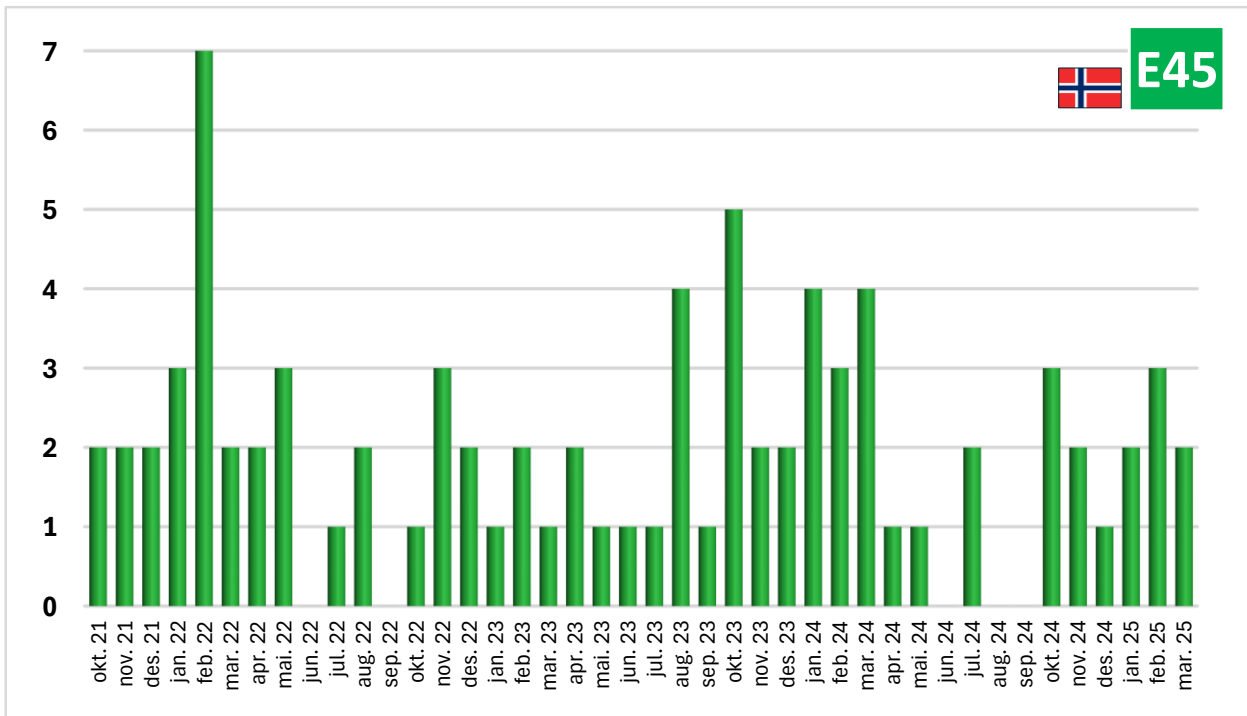
Figure 7-16: 83 road closures, E45 Norway (Oct.2021-Mar.2025)

As illustrated in figure 7-16, the monthly distribution of closures along the Norwegian section of E45 reflects this winter dominance, with peaks in the colder months and fewer incidents during summer, when closures are typically linked to accidents or isolated events.

The E45 in Norway ranks second in the region in terms of the number of closures. During the observation period, 83 closures were recorded, 73% of which occurred during the winter months. Available statistics indicate that these closures are not solely attributable to weather conditions. Instead, they are likely the result of **multiple contributing factors**, including:

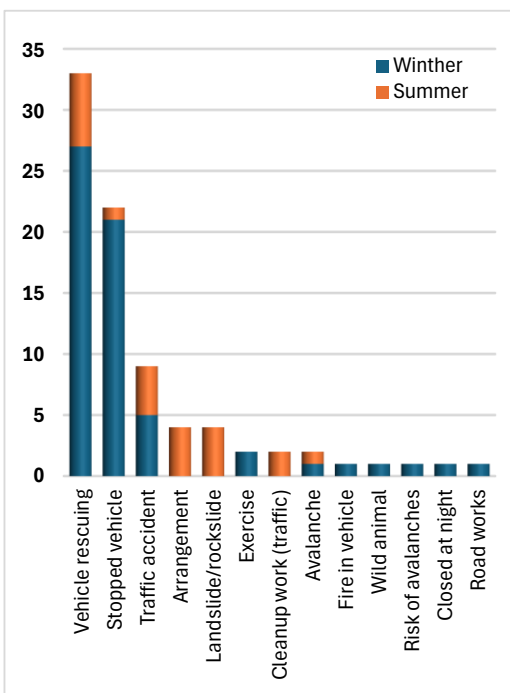
Figure 7-17: Causes of Road Closures on E45 (Norway)

Causes of road closures on E45 (Norway)

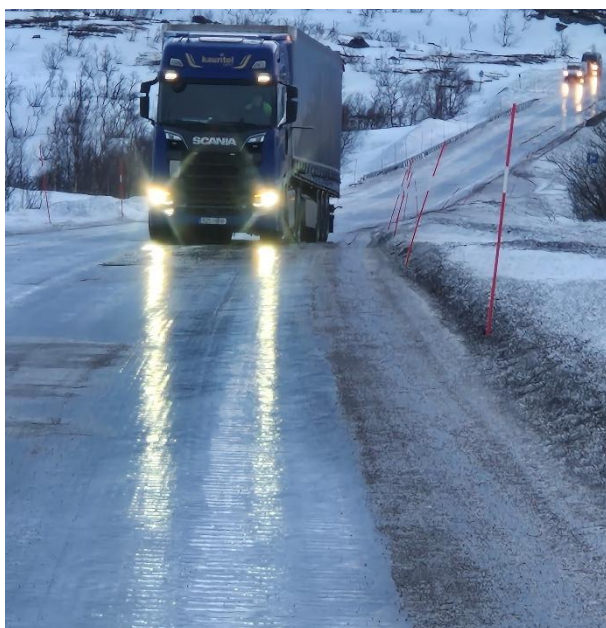
#### E10 Bjørnfjell – A challenging road section

The border crossing between Norway and Sweden at Bjørnfjell represents **the most challenging road section** in the region. Winter conditions frequently result in reduced mobility, closures, and convoy driving, making this corridor particularly vulnerable.

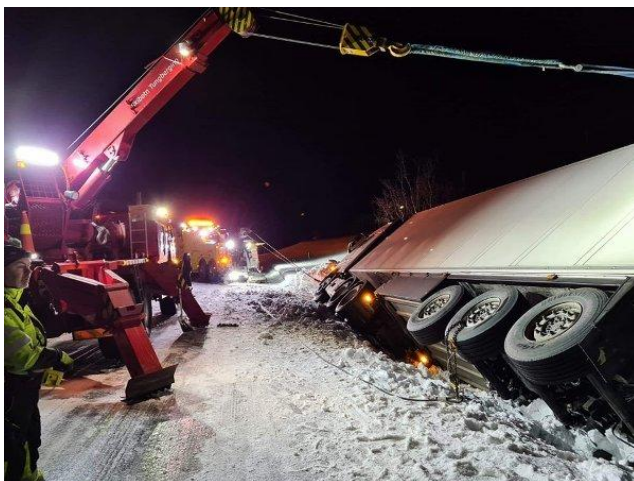
*Picture 8-2: Heavy transport off the roadside (Photo: Skibotn Tungberging AS)*

In December 2024, a heavy truck veered off the roadway on Road 21 (E8) between Kilpisjärvi and Palojoensuu. The vehicle left the road surface and came to rest off the roadside. Weather and road conditions in the area are known to be challenging during winter months, which may have contributed to the incident.

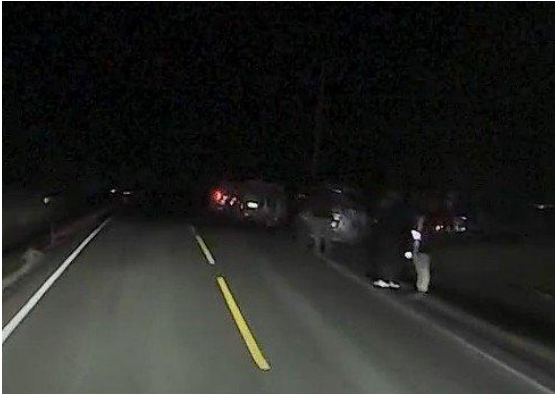
The picture illustrates Northern Light tourists on the E8 roadway, highlighting a recurring traffic safety challenge. The photo was taken by a heavy truck driver and published in Newspaper Nordlys. According to the driver, such incidents are not isolated but occur along the entire stretch between Skibotn in Norway and Karesuvanto in Finland.

This situation underscores the risks associated with **unregulated tourist activity**, where vehicles frequently stop or park directly on the roadway to observe the Northern Lights.

Such behaviour creates hazardous conditions for professional drivers and other road users, adding to the operational challenges of winter traffic management in the region.

On the E8 in Norway, traffic safety is further complicated by the presence of large numbers of **foreign tourists visiting to experience the Northern Lights**. The tourist activity appears to be insufficiently regulated, with vehicles frequently parking or stopping in the middle of the roadway. This behaviour creates **hazardous traffic situations** and adds to the operational challenges faced by professional drivers.

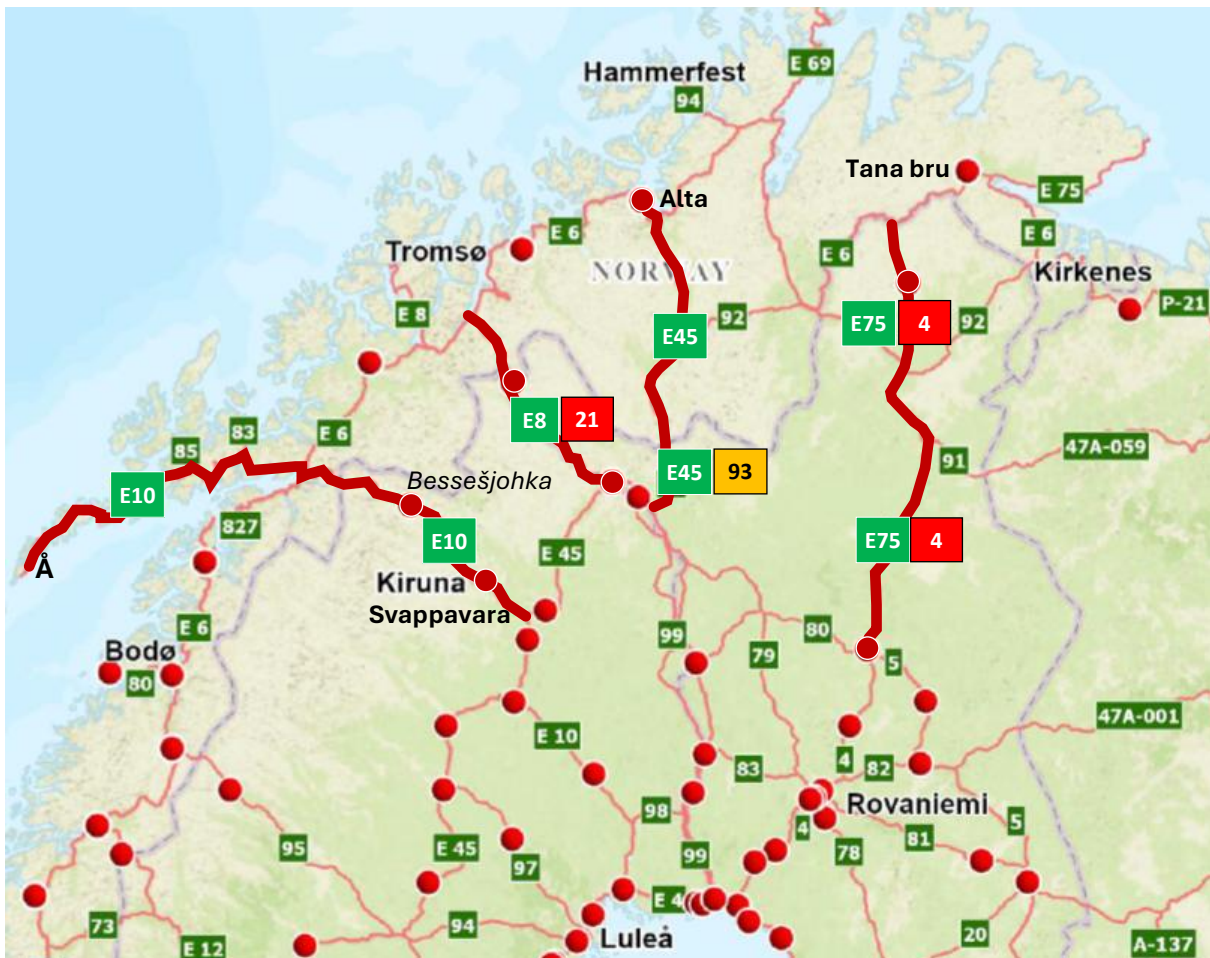
Figure 8-4: Existing 24h -rest areas (2021)

The map below (figure 8-4) , reproduced from 24-hour Rest Areas in the Barents Region (2021), provides an overview of existing and planned 24-hour rest areas as of 2021.

It illustrates **the geographic distribution of facilities across the western part of the Barents Region**.

The map indicates that there are **few rest areas in the northern parts of the western Barents Region**, including the corridors most frequently mentioned by drivers, such as the E10 and the northernmost sections of Finland. **A 24h rest area in Kiruna is added to the original map. A 24-hour rest area located in Kiruna has been incorporated into the original map.**

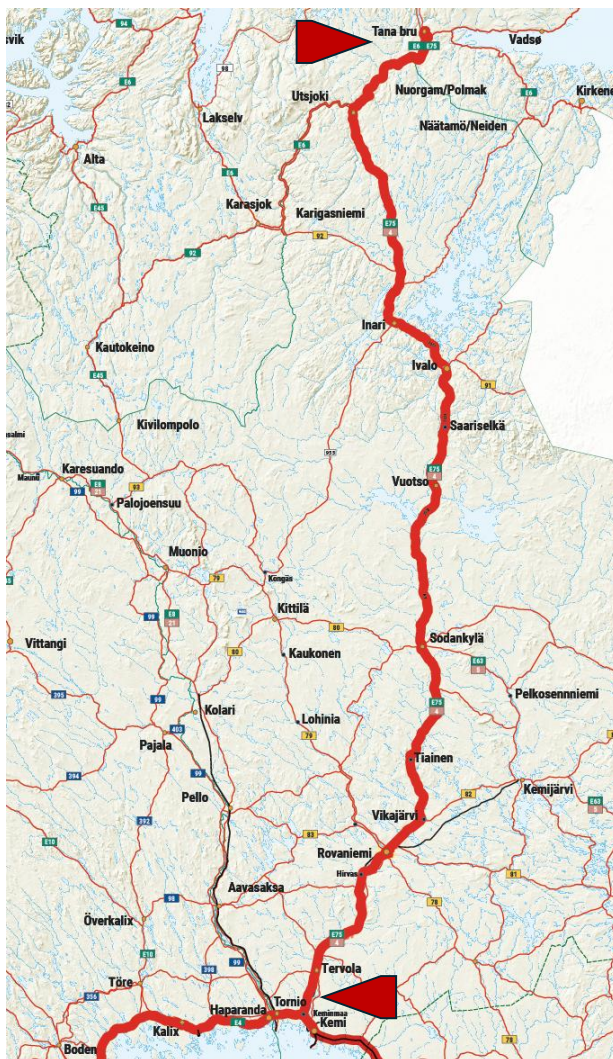
Figure 9-1: Corridor 1

The industry share table presented in figure 9-1 reflects the average distribution of industrial transport activity across the entire Corridor 1 (Norway and Finland) for the year 2023. The figures were compiled and published in the project’s market report of April 2025, ensuring that the analysis is based on the most recent and validated dataset available at the time of reporting.
